Inspection Report

1313 City Street
Carrollton, TX 75044

Texas Star Home Inspections

PROPERTY INSPECTION REPORT FORM

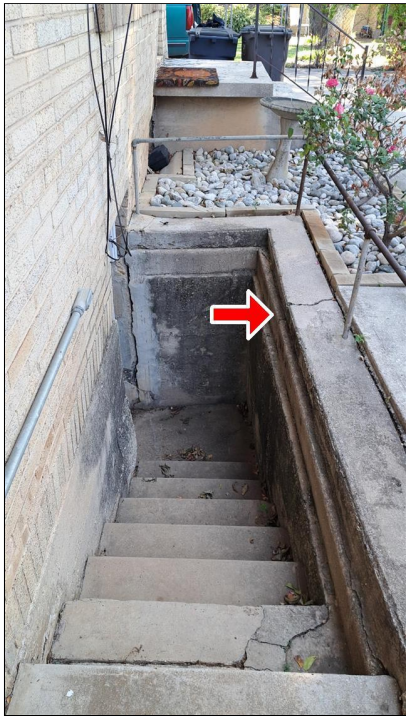
A. Item 1 (Picture)

1. There were cracks observed at the perimeter of the foundation at the back of the home.

Due to the amount of foundation and/or structural movement in various locations I recommend having a qualified foundation professional evaluate the foundation and repair or replace as needed.

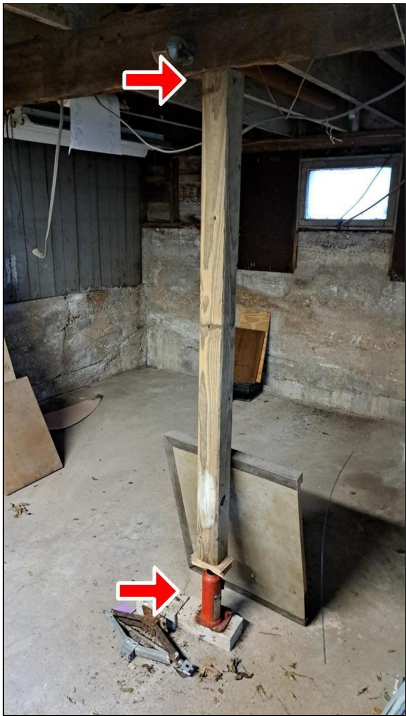
A. Item 2 (Picture)

2. There was a post and a Jack observed supporting the structure in the basement.

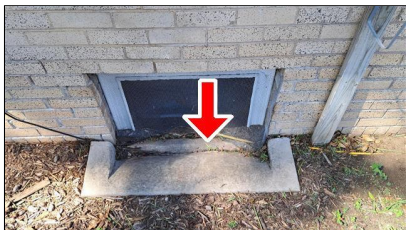
B. Item 1 (Picture)

The back part of the home was observed having wall structure and windows at the perimeter of the basement that were lower than the grade next to the walls.

The grade in places was observed covering the bottom of the bricks at the bottom of the walls.

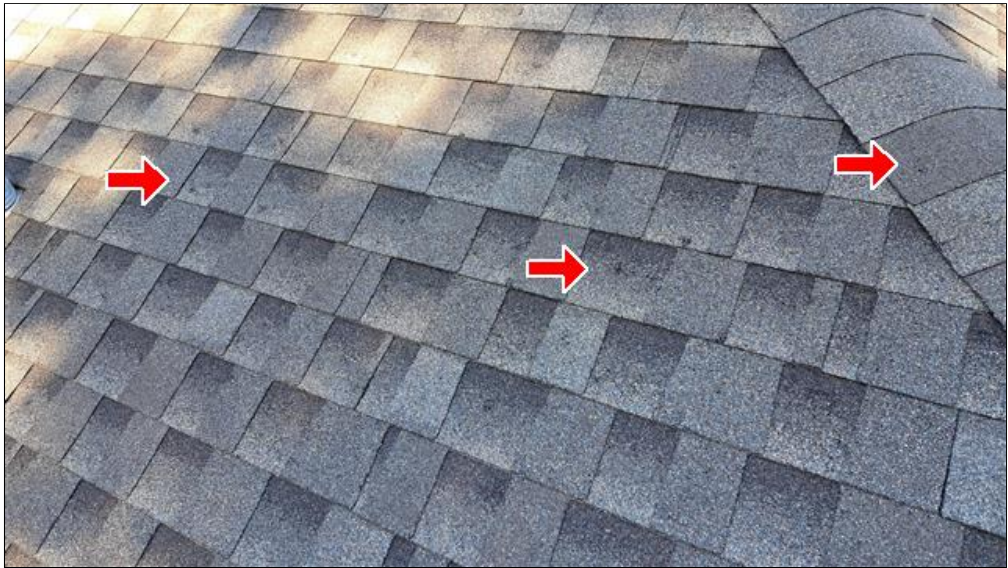
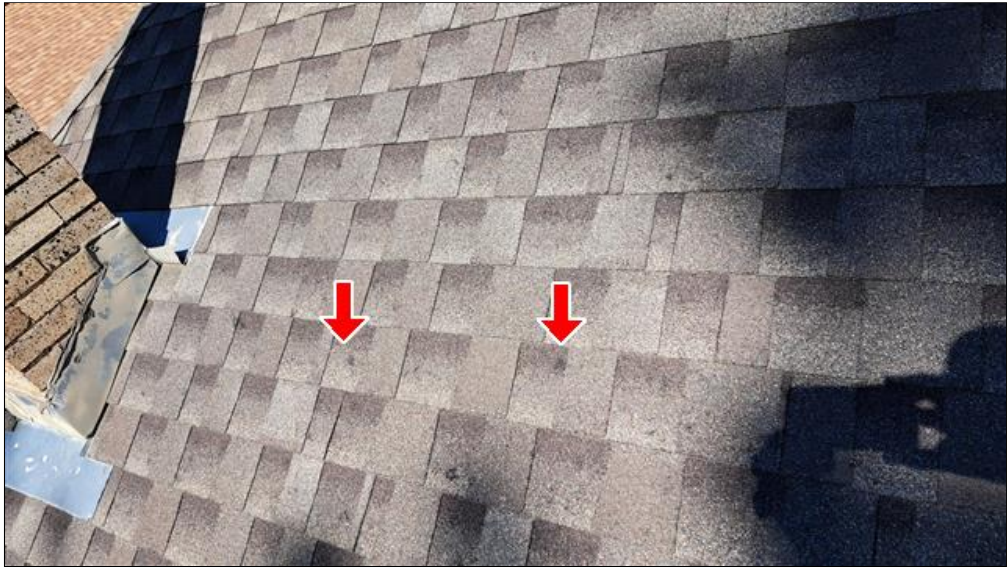
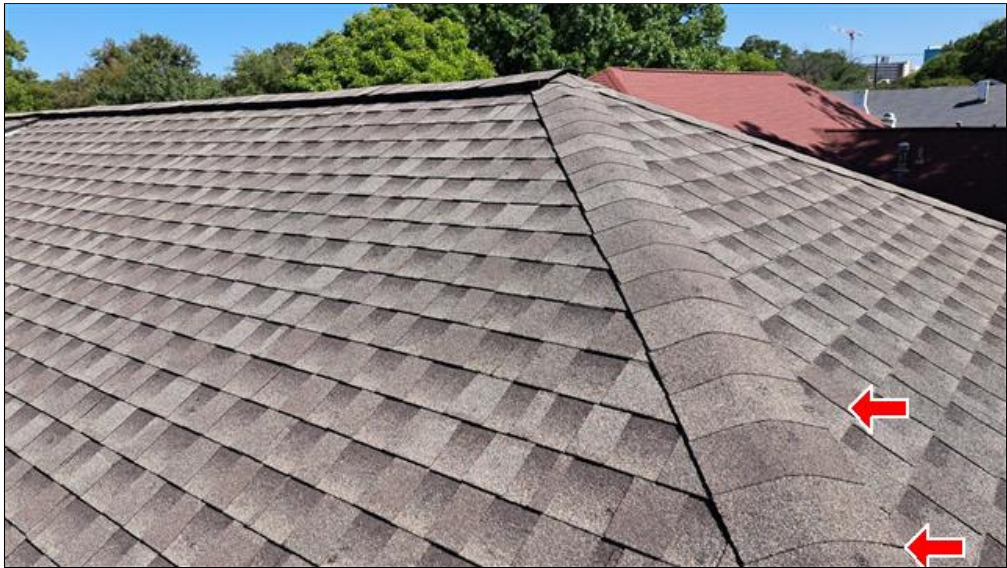
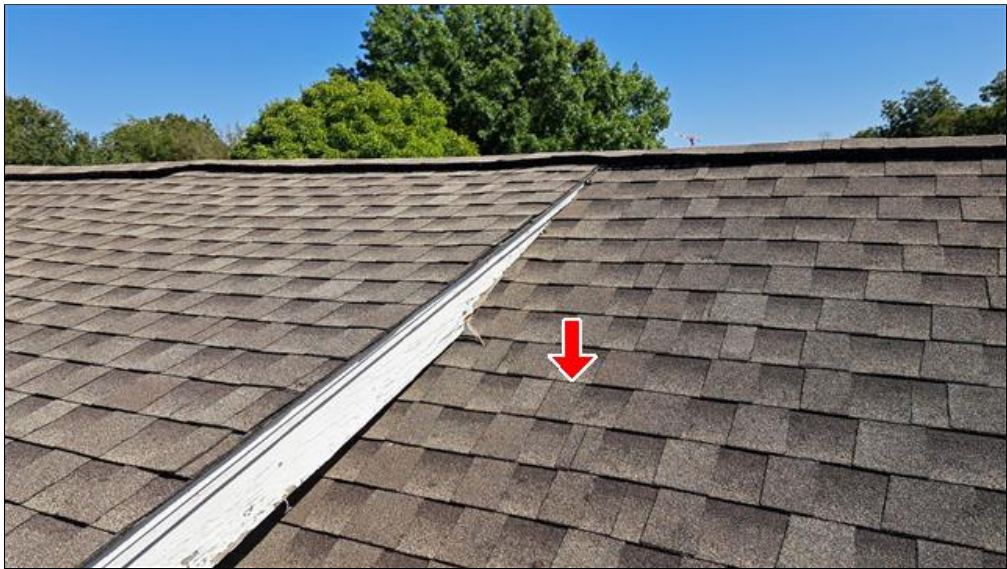
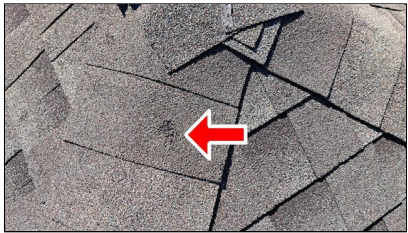
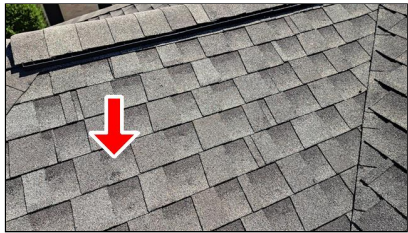
The roof was observed having visual signs of hail damage in various locations.

I recommend having the roof checked by the sellers insurance provider for damage.

Alternatively, I recommend having the roof checked by a licensed professional roofing contractor.

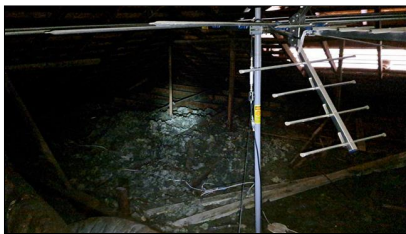
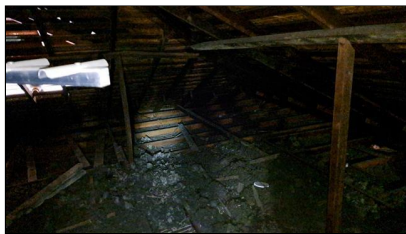
- Pictures numbered 1 & 2. There was a significant amount of debris observed inside the attic.
3. There were roof braces observed not supported by strong backs.
4. Attic view.
5. There were uneven roof structure surfaces observed in various locations.
6. There was wood trim and rafters observed rotted at the sides of the dormers.

I recommend having a qualified structural engineer or master carpenter evaluate the roof structure and repair or replace as needed.

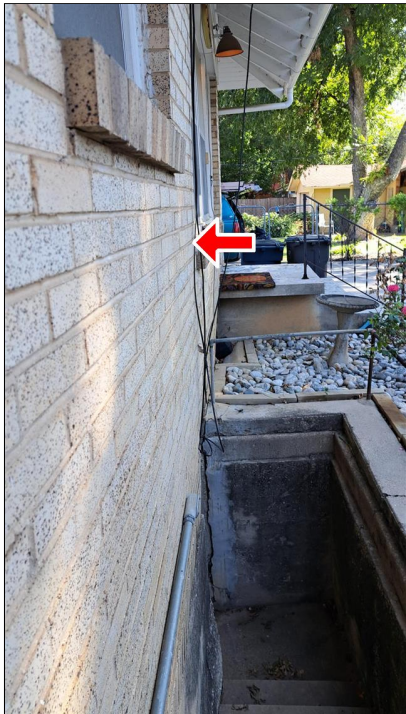
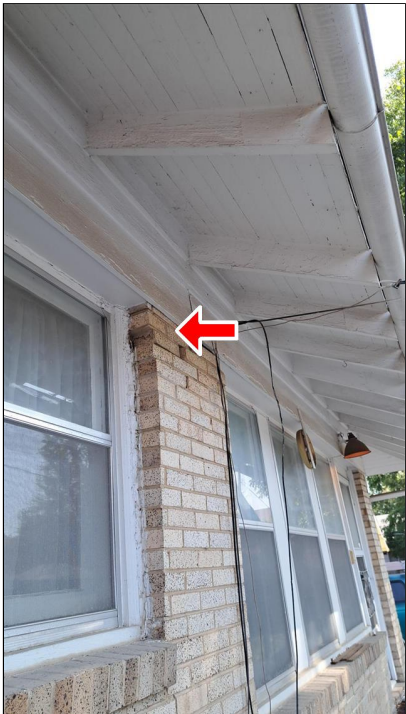
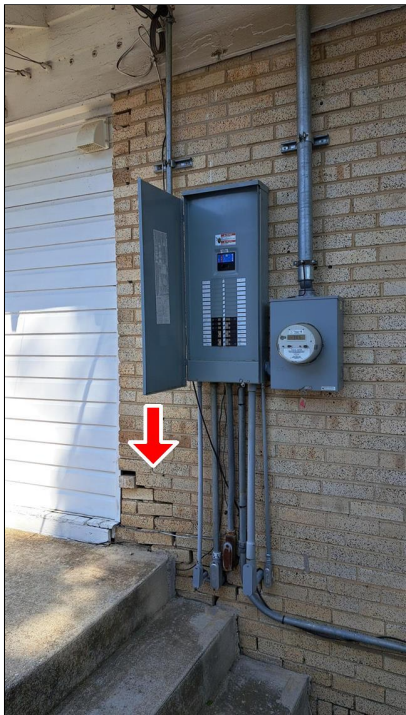
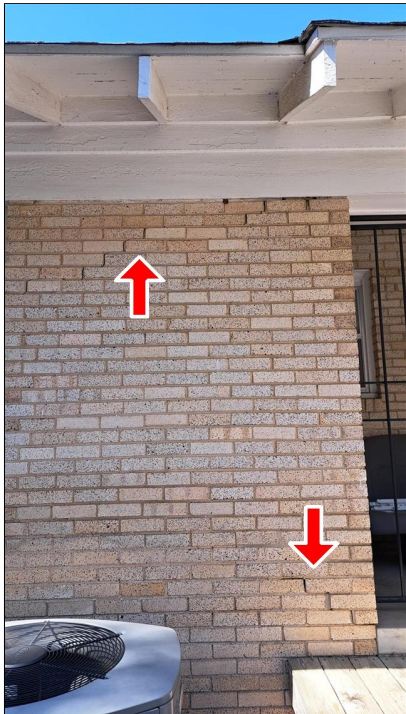
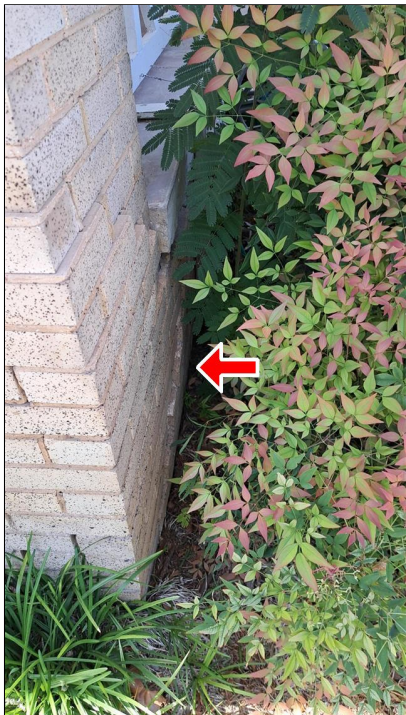
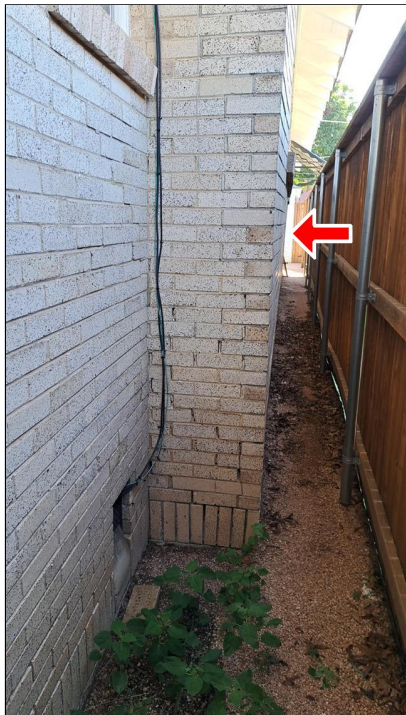
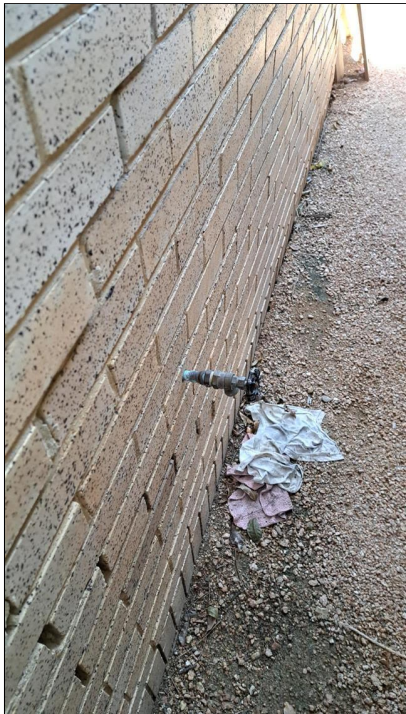
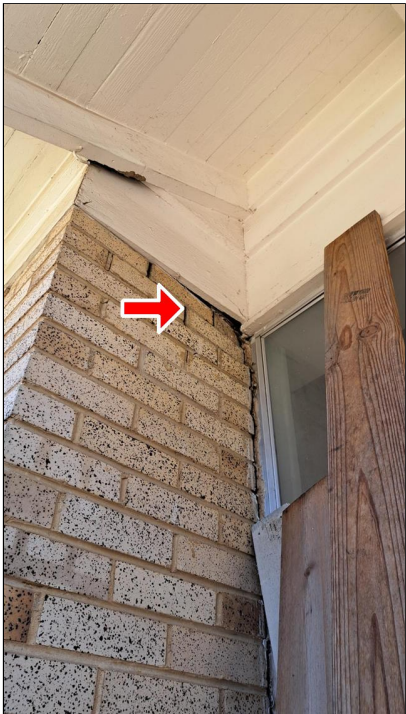
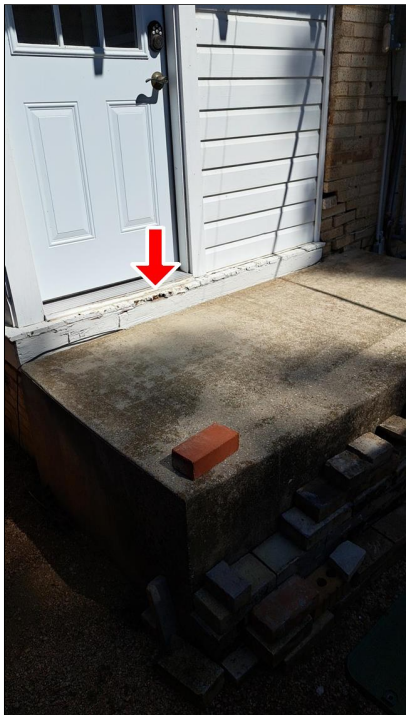
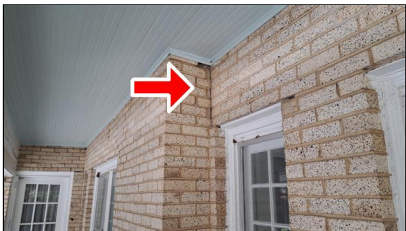
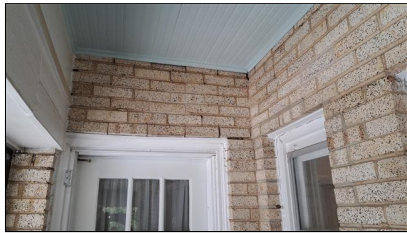
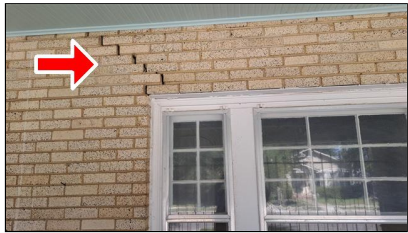
Pictures numbered 1 - 15 are pictures taken of cracks in the brick veneer wall covering in various locations. Also there were walls that were observed bowed.

The exterior brick veneer wallcovering was observed having major cracks at all four sides of the home.

I recommend having a qualified brick mason evaluate the brick veneer wallcovering and repair or replace as needed.

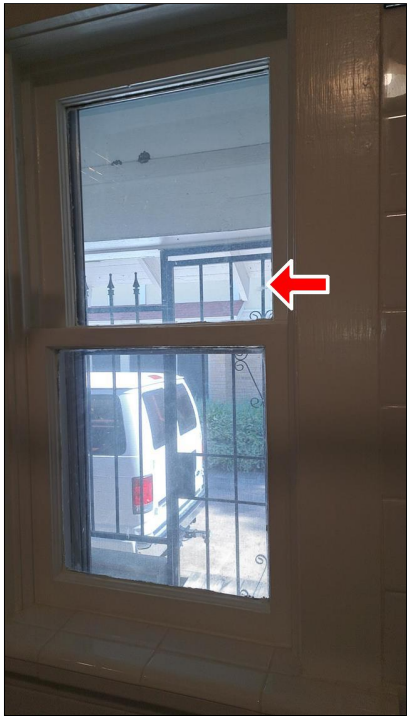
J. Item 1 (Picture)

1. The window next to the bathtub was observed painted shut and did not have a tempered safety glass label.
2. There was Windows observed that would not open.
3. There were Several Windows observed that did not have window locks.
4. There were Windows observed that did not have window screens.
5. The windows were observed being single pane type windows which are less energy-efficient by today's standards..
6. There were window openings observed having two sets of windows which can be a hindrance in getting out of the home in an emergency.

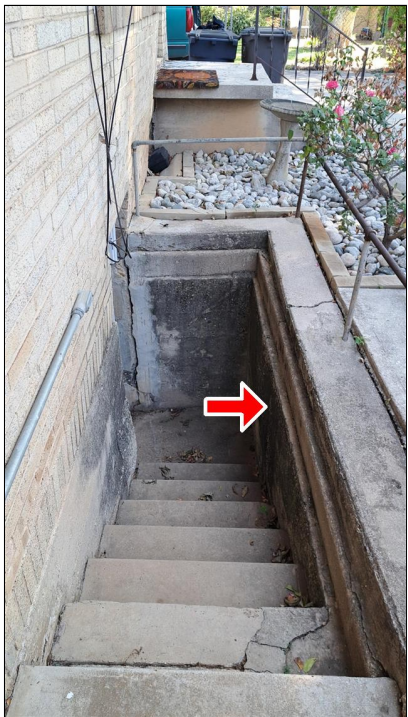
K. Item 1 (Picture)

Comments:
The stairs leading to the basement were observed not having handrails.

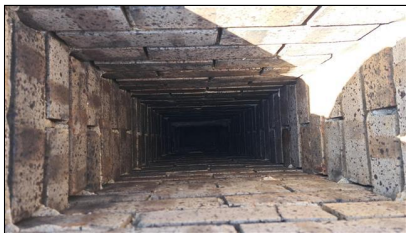
L. Item 1 (Picture)

1.After several attempts I was not able to light the fireplace.

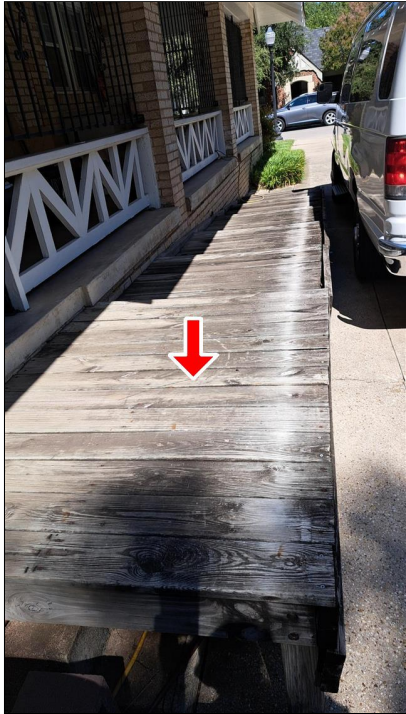
M. Item 1 (Picture)

1.The steps located at the side of the home were observed not having handrails.

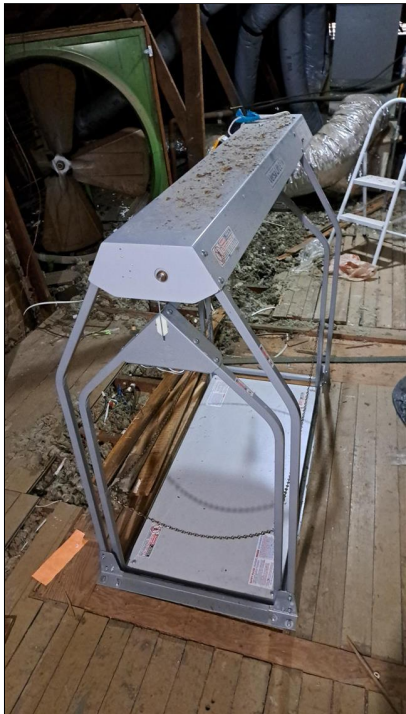
P. Item 1 (Picture)

- Comments:
- 1.I did not operate the elevator lift located it in the attic at the time of the inspection.
 - 2. I did not locate a basement sump pump.

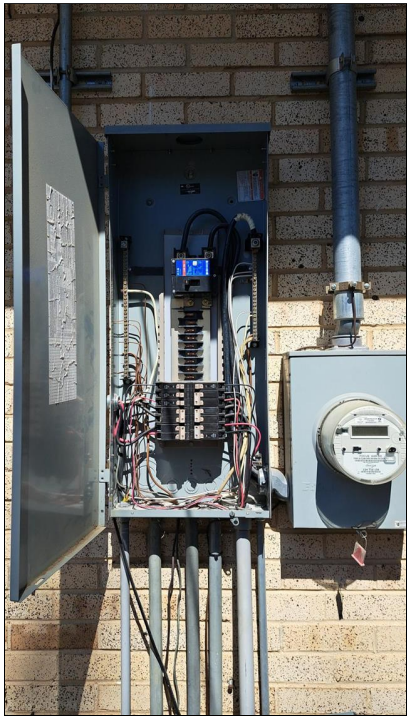
A. Item 1 (Picture)

Pictures numbered 1 & 2. View of the main service panel and sub panels located in the basement.

I recommend a licensed professional electrician evaluate the service panel and repair as needed.

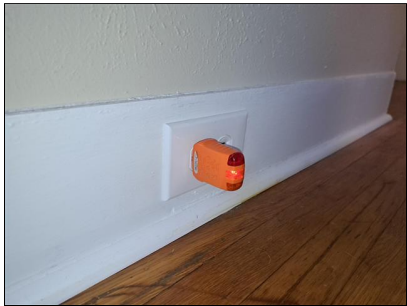
B. Item 1 (Picture)

1. There were wall receptacles that indicated open ground on the electrical tester at some of the three-pronged receptacles.

All such installations should be labeled "No Equipment Ground" on each receptacle that applies. Grounding of all "three-pronged" receptacles or protection with a Ground Fault Circuit Interrupter (GFCI) on each is recommended for safety reasons, prior to the close of escrow or after taking possession of the property.

I recommend having a qualified electrician evaluate the entire branch circuit system and repair or replace as needed.

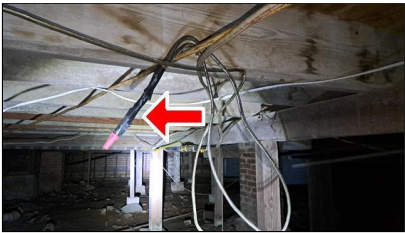
B. Item 2 (Picture)

2. There was wire splicing observed in the crawlspace. these wires were observed not connected inside a junction box.

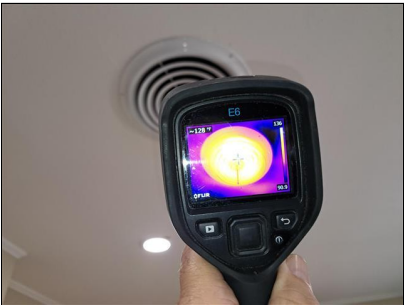
A. Item 1 (Picture)

- 1. The furnace was observed hating to 136° with a differential of 55°.
- 2. View of the furnace.
- 3. View of the furnace and operation.

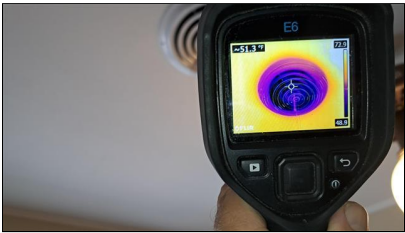
B. Item 1 (Picture)

1.The AC system was observed cooling to 48° with a differential of 18°.

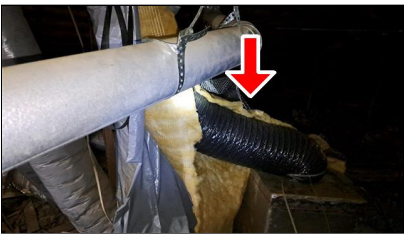
C. Item 1 (Picture)

Comments:
There was AC duct was observed being a type of duct that was made during the 1980s which is known for the outer plastic wrapping deteriorating at attic temperatures.

I recommend a qualified HVAC contractor evaluate the AC duct that is damaged and repair or replace as needed.

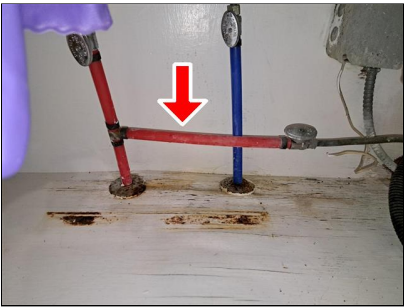
A. Item 1 (Picture)

- 1. There was a water leak observed underneath the kitchen sink.
- 2. There was a disconnected water supply pipe observed in the laundry room located in the basement.

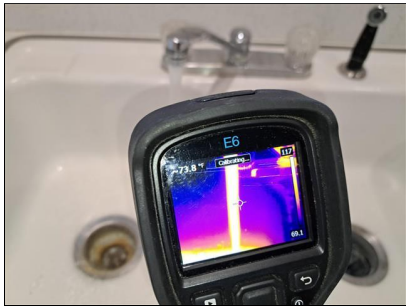
C. Item 1 (Picture)

- 1.The water heater was observed heating the water to 117°.
- 2.View of the water heater data plate.
3. There was a significant amount of rust observed at the bottom of the water heater.
4. I recommend insulating the water supply pipes connected to the water heater.
- 5.The water heater was observed not mounted 18 inches off the floor with a drain pan underneath the water heater with a drain line that drains to the exterior of the home.

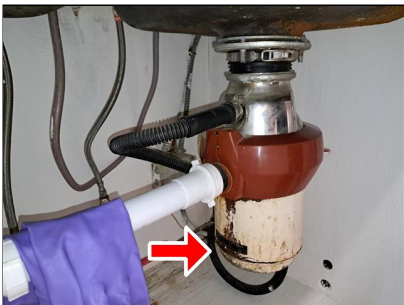
B. Item 1 (Picture)

Comments:
1.The exterior of the garbage disposal was observed having rusted metal surfaces.

2.The garbage disposal was observed leaking water at the bottom.

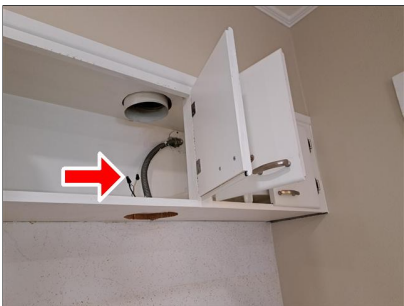
C. Item 1 (Picture)

Comments:
There was open wire connections observed where the exhaust fan for the stove hood is located.

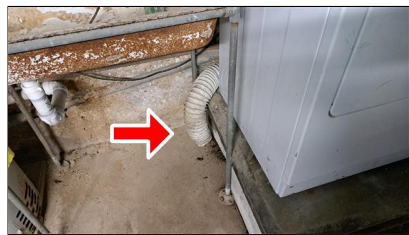
H. Item 1 (Picture)

Comments:
The exhaust vent pipe for the close dryer was observed being a plastic pipe pipe and not a foil vent pipe.

The dryer vent pipe did not vent to the exterior of the home.

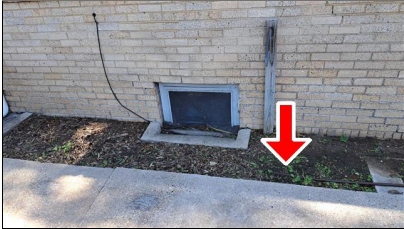
A. Item 1 (Picture)

1. There was exposed soaker hose observed at the perimeter of the foundation.

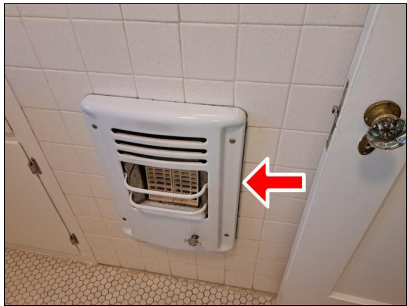
E. Item 1 (Picture)

1.I recommend removing the wall heater located in the bathroom and capping the gas supply line.
