Inspection Report

1313 City Street
Carrollton, TX 75044

Texas Star Home Inspections

PROPERTY INSPECTION REPORT FORM

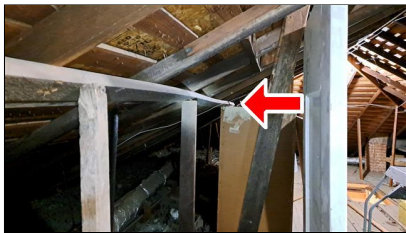
D. Item 2 (Picture)

- Pictures numbered 1 & 2. There was a significant amount of debris observed inside the attic.
3. There were roof braces observed not supported by strong backs.
4. Attic view.
5. There were uneven roof structure surfaces observed in various locations.
6. There was wood trim and rafters observed rotted at the sides of the dormers.

I recommend having a qualified structural engineer or master carpenter evaluate the roof structure and repair or replace as needed.

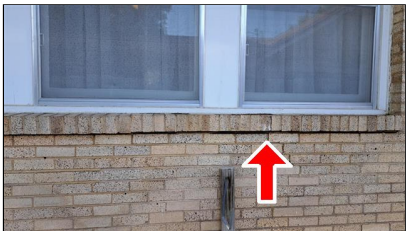
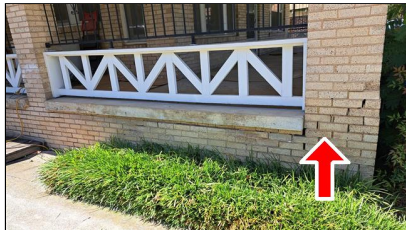
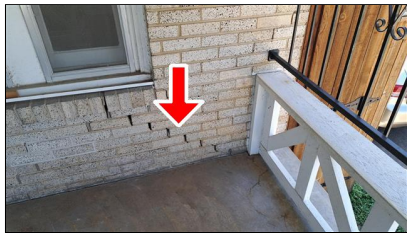
Pictures numbered 1 - 15 are pictures taken of cracks in the brick veneer wall covering in various locations. Also there were walls that were observed bowed.

The exterior brick veneer wallcovering was observed having major cracks at all four sides of the home.

I recommend having a qualified brick mason evaluate the brick veneer wallcovering and repair or replace as needed.

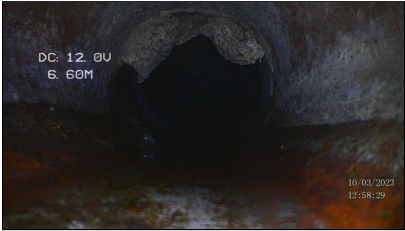
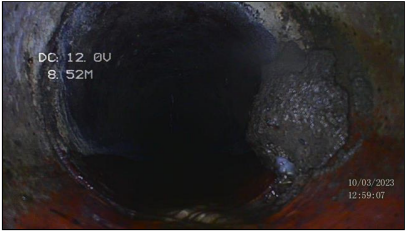
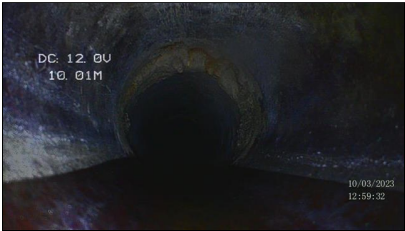
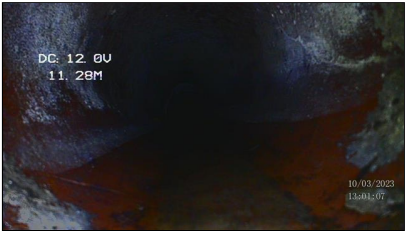
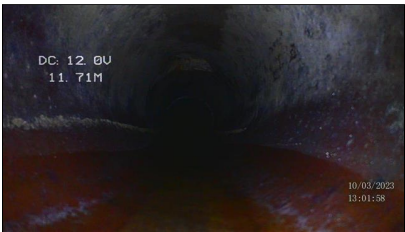
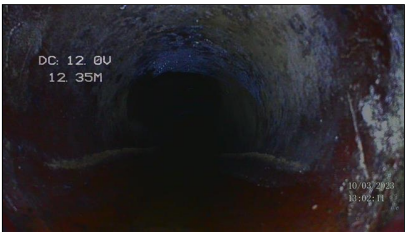
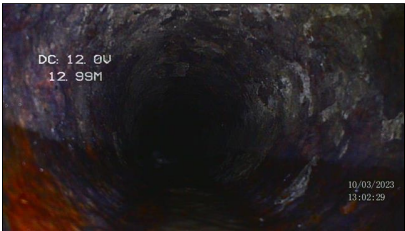
When a home has cast-iron sewer drain pipes, the cast-iron sewer drain pipes are known for corroding from the inside outward.

There were other obstructions observed inside the sewer drainpipe.

There were sections of the cast-iron drainpipe that was heavily corroded.

I recommend having the sewer drain pipes evaluated by a qualified professional plumber.

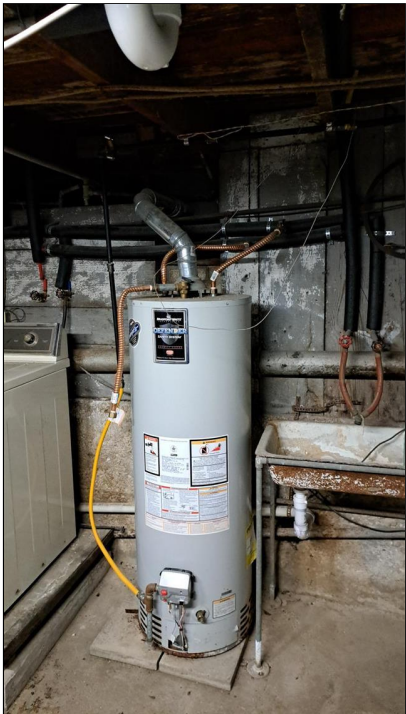
C. Item 2 (Picture)

- 1.The water heater was observed heating the water to 117°.
- 2.View of the water heater data plate.
3. There was a significant amount of rust observed at the bottom of the water heater.
4. I recommend insulating the water supply pipes connected to the water heater.
- 5.The water heater was observed not mounted 18 inches off the floor with a drain pan underneath the water heater with a drain line that drains to the exterior of the home.

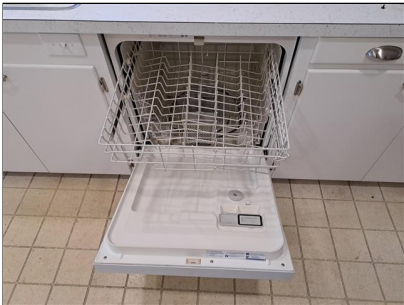
A. Item 1 (Picture)

Comments:
View of the dishwasher.

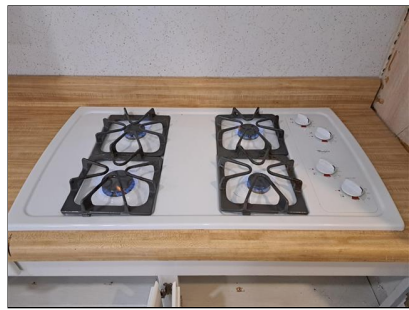
D. Item 1 (Picture)

Comments:
Pictures numbered 1 & 2. View of the stovetop and oven in operation.

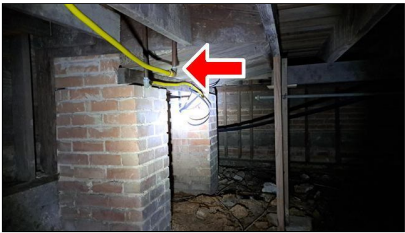
E. Item 2 (Picture)

2. There was stranded metal gas line observed underneath the home that was not bonded. Bonding of stranded metal gas line requires an electrician to make the repair.
